MG TF Stepspeed Primary Bearing Replacement

(produced by David Reed)

Whining noise from CVT gearbox

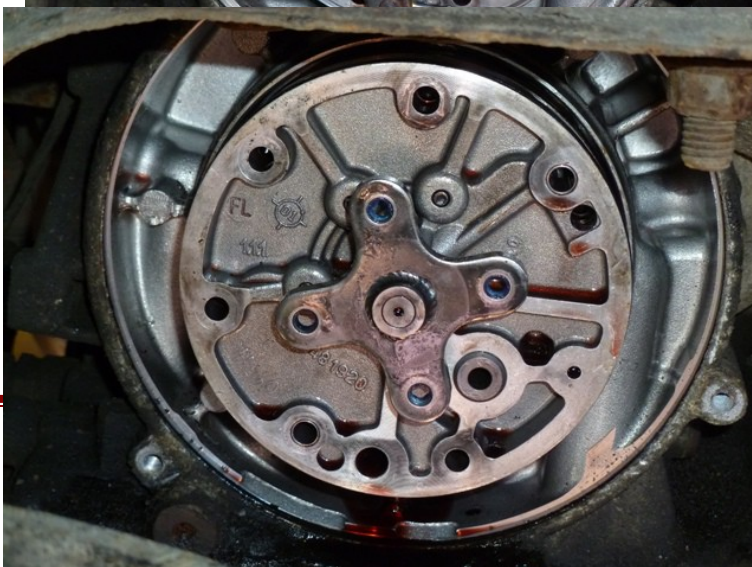
Step

- Pump shown partially withdrawn

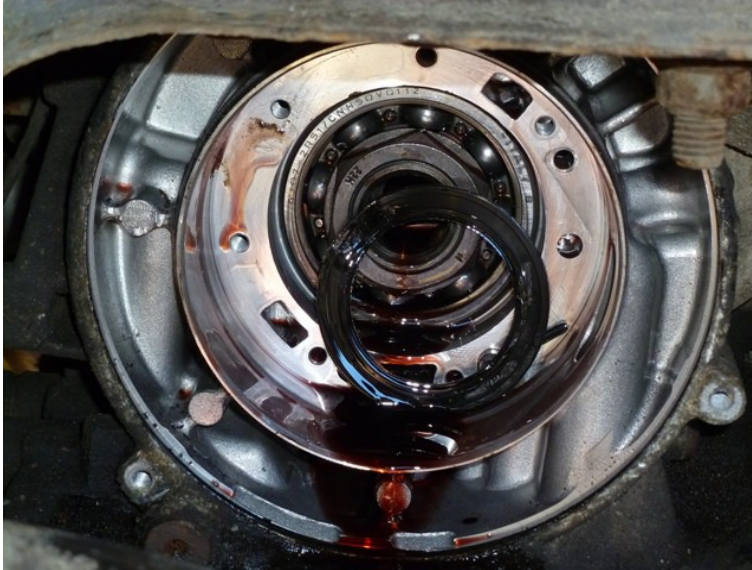
Step 7

- Lever out primary bearing rubber seal
- Note that the bearing has lost its factory lubricant and transmission fluid has taken its place (this I feel is the casue of the premature bearing failure)

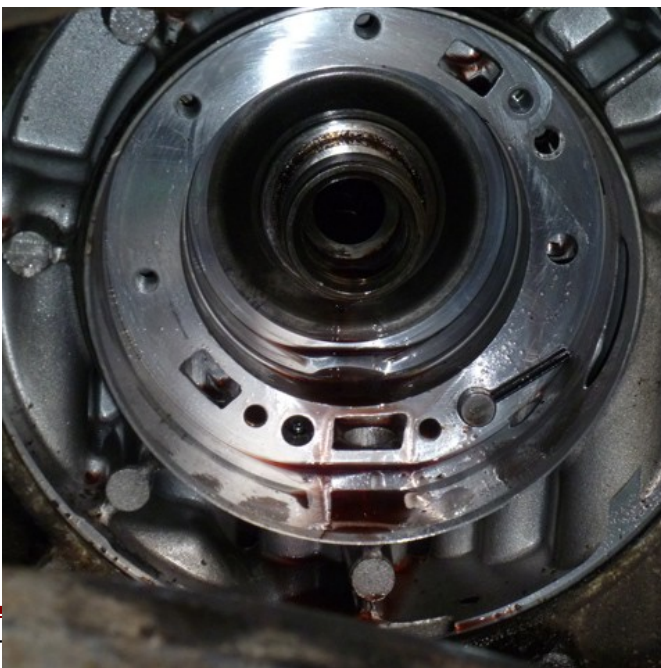
Step 10

- Primary bearing removed
