MG TF Stepspeed Primary Bearing Replacement

(produced by David Reed)

Whining noise from CVT gearbox

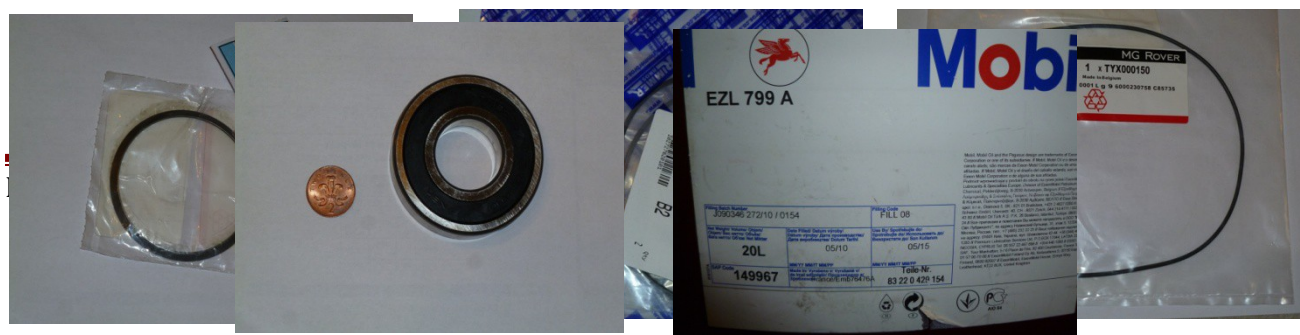
- As per [MG Rover Technical bulletin TB0116 issue 2 – 24th March 2004](#)
- CVT oil ECL799 to replace any lost oil which is displaced from the oil pump (oil loss was no more than ½ a litre). Others claim there is alternative oils available, however I played safe and bore the cost of the genuine article.

(please note no picture of TYG000270 (4 replacement bolts)

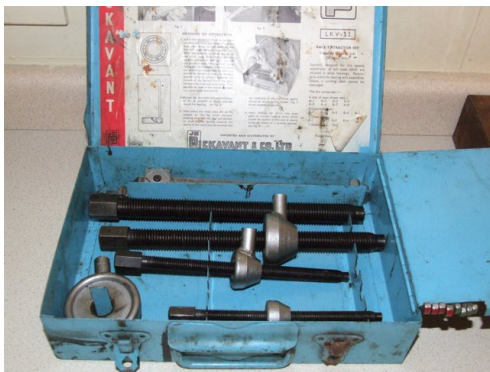
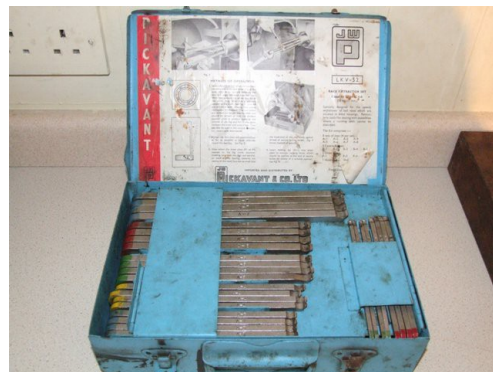
- MG Rover Assemble tool part numbers 44-022 and 44-023. I couldn't locate these so purchased a Sykes Pickavant LKV 52 Ball Bearing Puller, Ball Race Extractor Kit (this kit is

extremely hard to obtain or hire. It could be possible to fabricate a tool for the purpose as it was found that the bearing was not a very tight fit).
